**Government of Nepal  
Aircraft Accident Investigation Committee 2023**

**Final Report**

**Accident Investigation of 9N-AJZ, AS350B3e**

**At Makalu Barun Area, Sipurung, Sankhuwasabha on 5<sup>th</sup> May 2023**

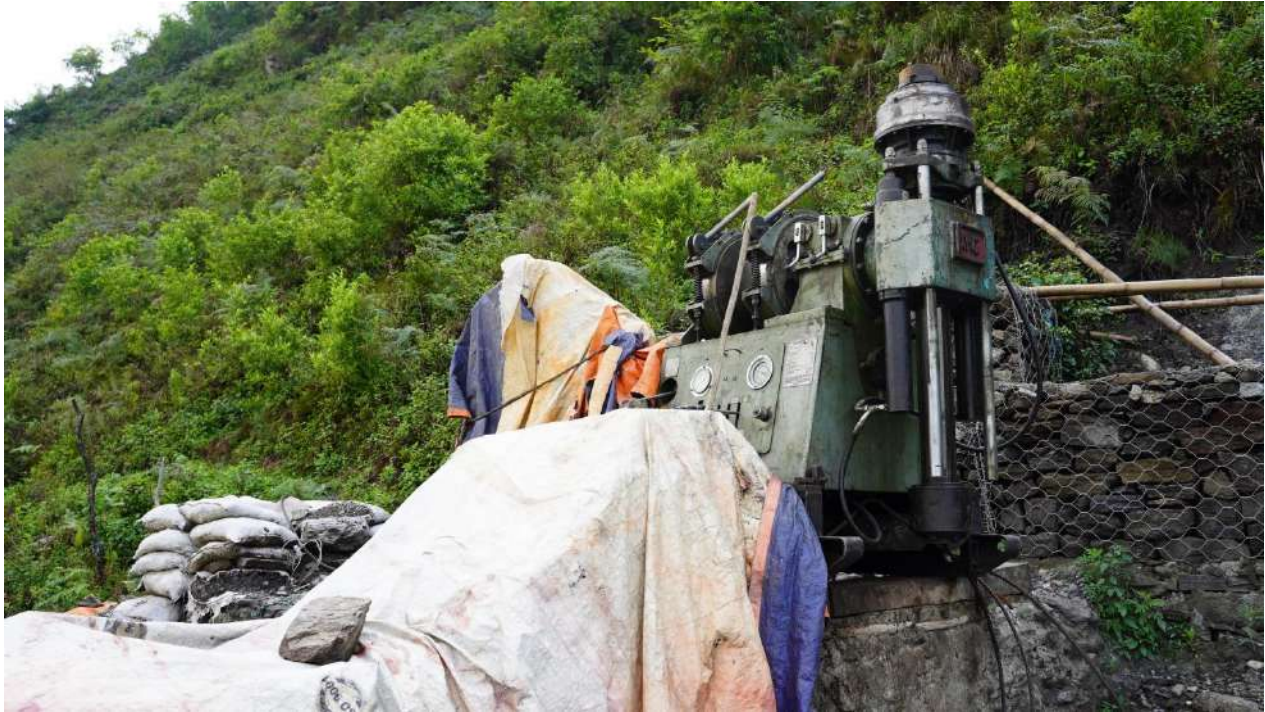
While the helicopter was on left skid contact partial hover<sup>#</sup> for S/N crew disembarkation followed by sling equipment unloads, pilot experienced a sudden imbalance causing a left tilt resulting in the rotor to strike the top end of a drilling machine located in the vicinity of the site.

Figure 1: Drilling machine stationed towards the east of intended point of left skid contact

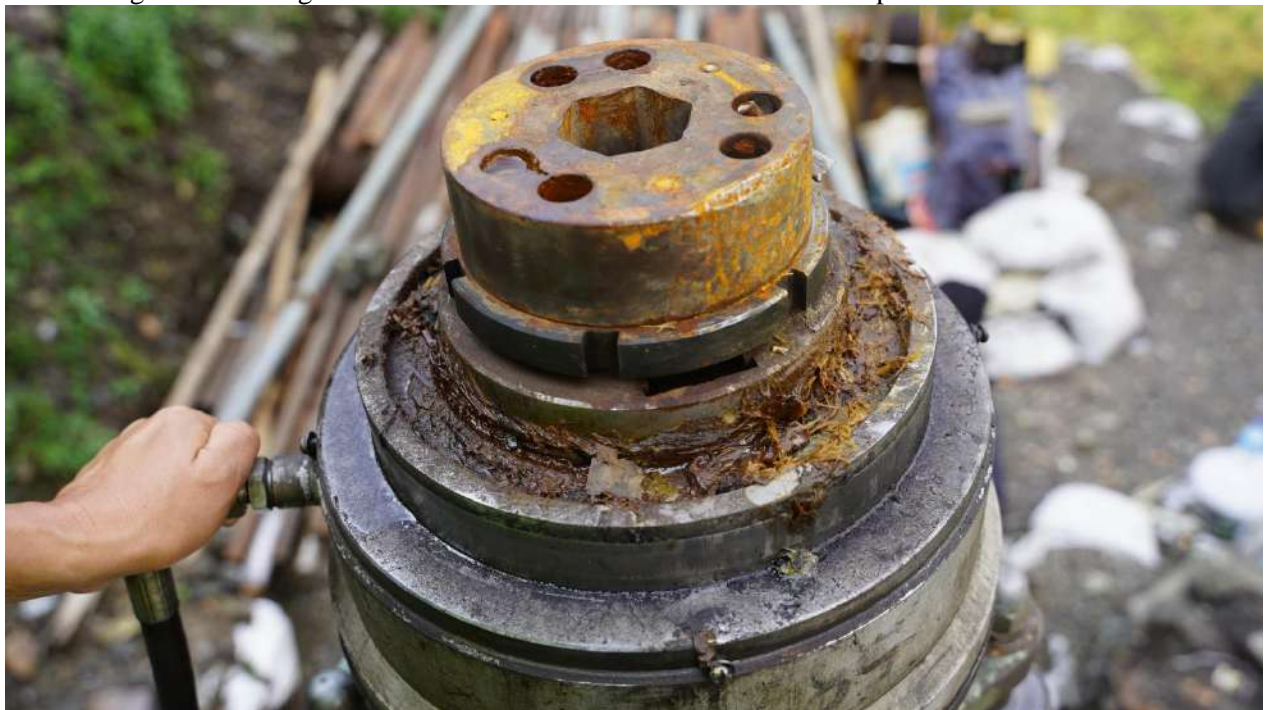
Figure 2: Impact point

by that time. However, upon minute inspection of the accident site, it is evident that the rotor impacted the top of the drilling machine causing a loss of control in flight. After that, the helicopter skid down and hit the tail rotor 8ft down the slope. The tail portion detached causing the helicopter to topple downslope several times before it came to a final rest at co-ordinates 27° 40' 43" N 87° 22' 12" E (Figure 5).

The most probable cause of the accident was an overcorrection input of the left cyclic control by the PIC in an attempt to counter the sudden shift in CG resulting in an impact with the drilling machine located at the vicinity while the helicopter was on a left skid contact partial hover.

1. All helicopter operators should develop SOP for skid contact partial hover operations. Such SOP should be evaluated and duly approved by CAAN.
2. The PIC should ensure that only trained personnel are onboard during sling operations.
3. CAAN should study the requirements of pilot trainings, develop a training syllabus and guidelines for skid contact (partial hover) operations.

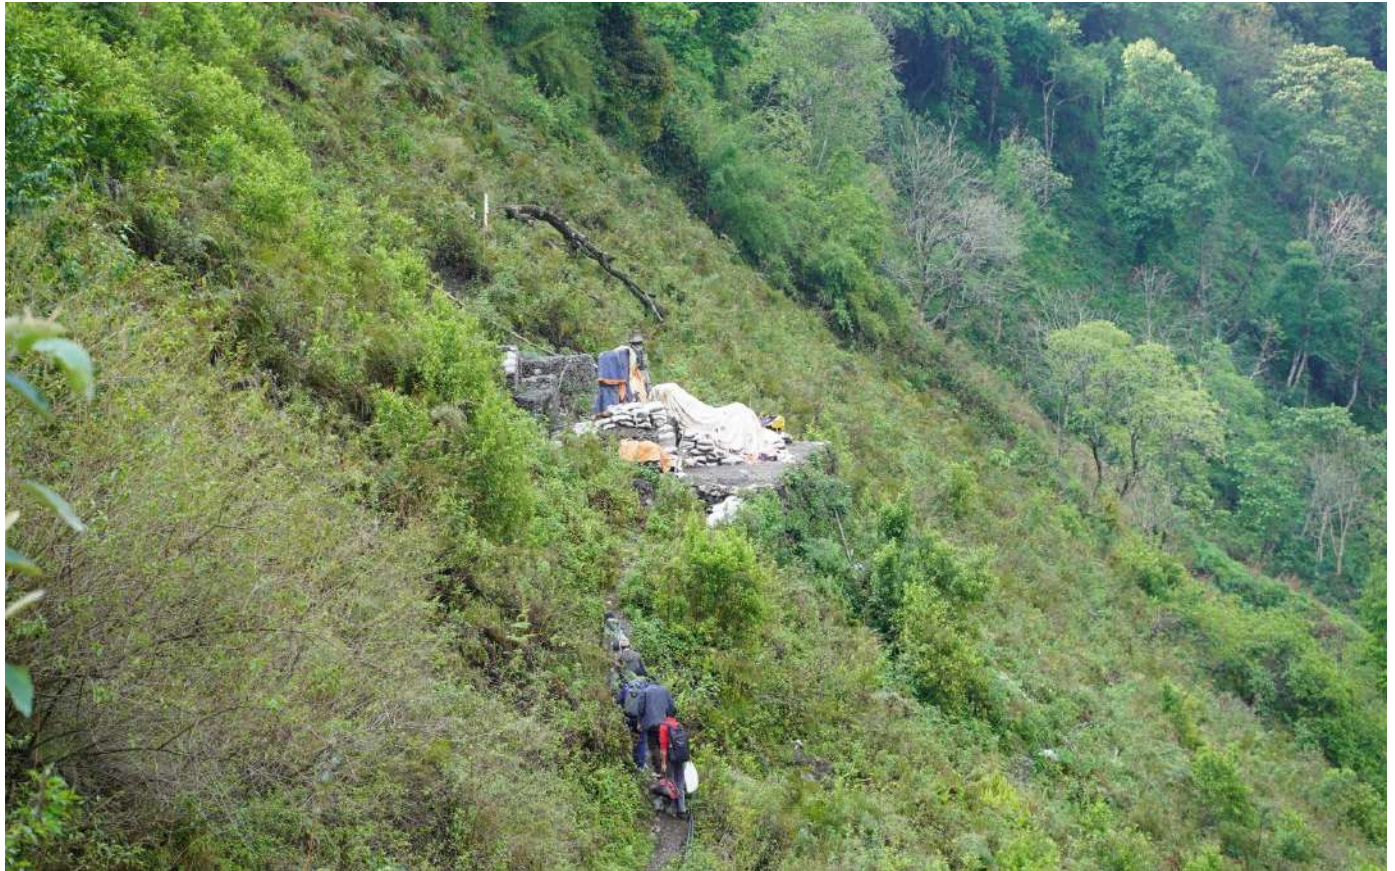
Figure 3: South view of the intended point of left skid contact

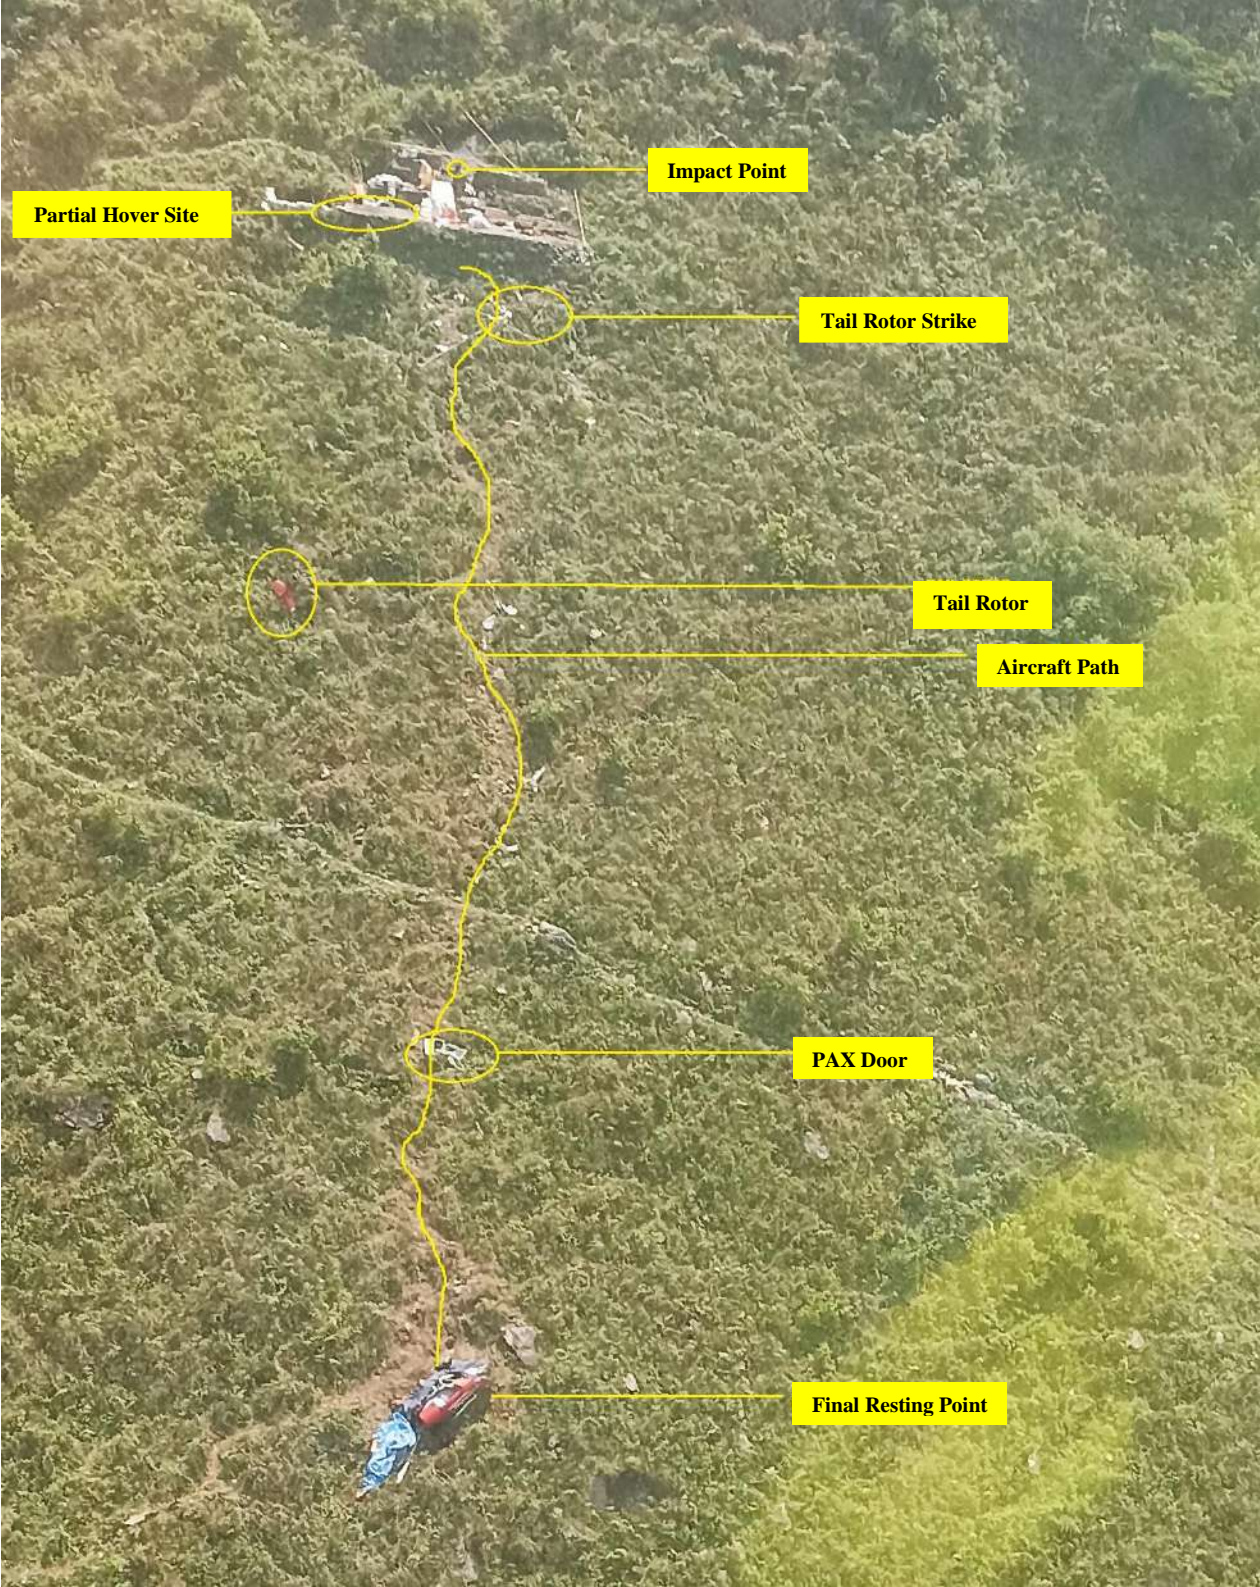
The helicopter was substantially damaged. Aircraft parts were found scattered around the vicinity as shown in Figure 4.

Due to the topographical complexities after the accident, the accident site could not be accessed immediately. The committee reached the accident site on 9<sup>th</sup> May 2023 (Figure 4). Most of the perishable information like initial impact marks and traces could not be identified and confirmed

Figure 4: Aerial View of the wreckage distribution

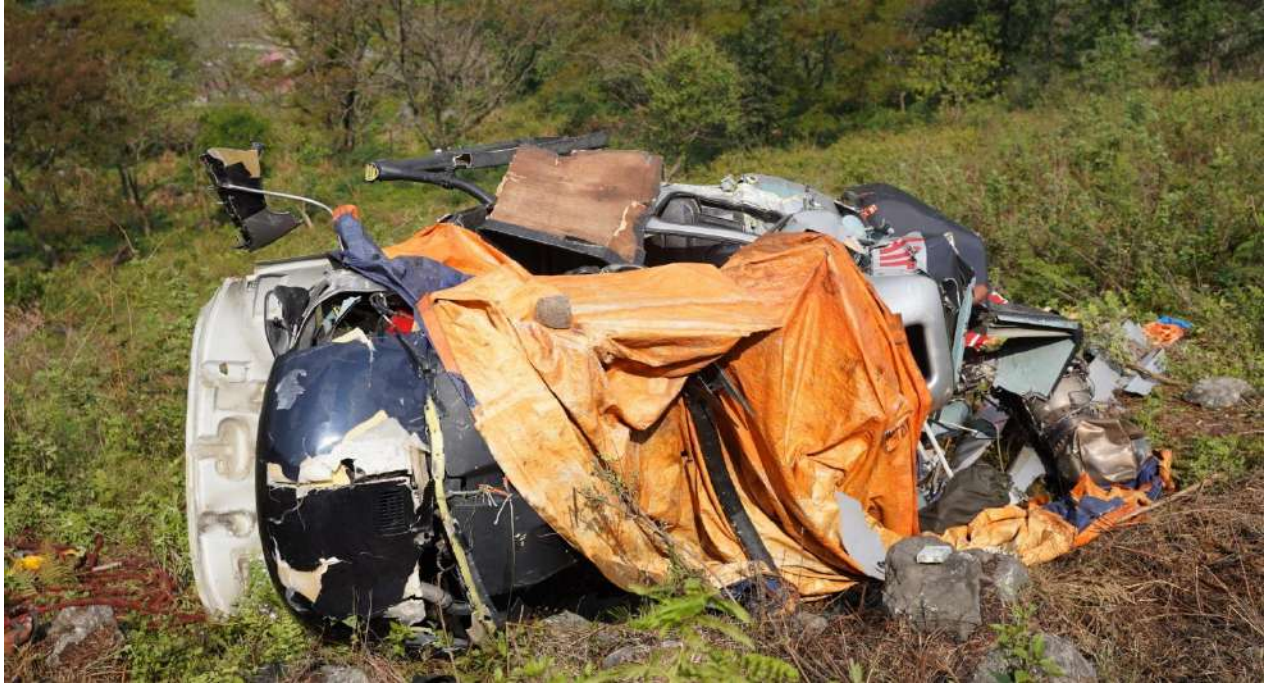
Figure 5: Helicopter Wreckage
